# Crawford Station MGP Site Chicago, Illinois

# **Weekly Field Progress Report**

Report Date: June 8, 2012

Activity Period: May 27, 2012 through June 2, 2012

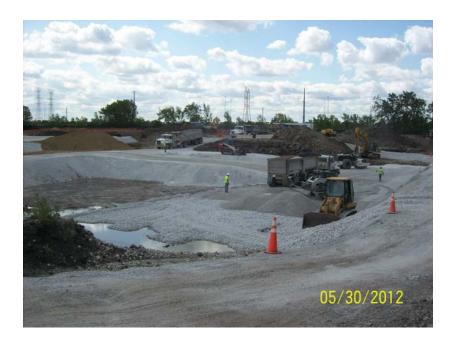
Description: Looking southeast from west property line sheeting at backfill operations in Areas B, C, D, E, F, and FA.

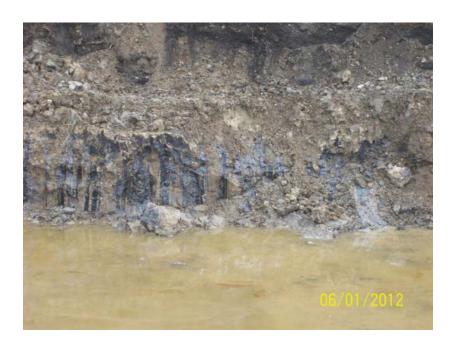
Description: Tar seeps at about 8 to 10 feet below ground surface (bgs) in the sidewall to be excavated in Area I, looking south.

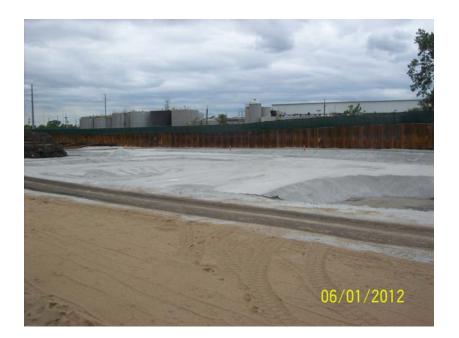
Description: View to southwest from sewer marker sand to CA-6 compacted backfill in Areas B, C, D, E, F, and

FA.

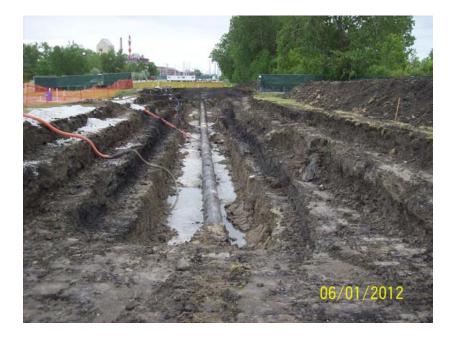
Description: Exposed 24inch High Pressure gas line as part of Peoples Gas pipeline integrity dig to fix detected corrosion spots, with Tecnica, BMcD, and NRT support. Looking east along south fence of site.

Representatives from Peoples Gas, including sub-contractors, remained on-site through the week to continue their quality assurance procedures on the 24 inch diameter high pressure gas line running through the southern portion of the RAA.
